Report 1443

THE EFFECTS OF ATOMIC WEAPONS ON ENGINEER HEAVY EQUIPMENT (U)

Project 8-12-75-001

25 April 1956

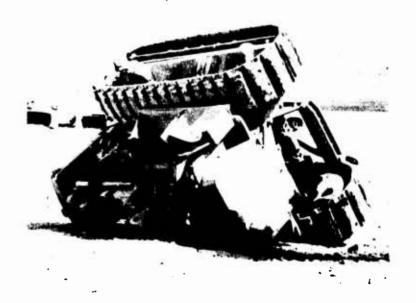
Al3322 Fig. 7. Caterpillar D-7 (without attachments), 2100 ft; after test.

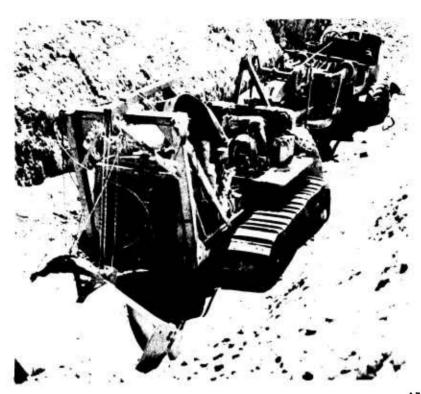
a. Tractors. At the 1600-ft range, the exposed D-6 tractor was completely destroyed. Dismemberment extended to primary assemblies and no component went unscathed. The D-8 tractor in the slot received only superficial damage; it could have been repaired by the operator. The sand blown into the slot was drawbar deep, but could not have prevented movement of the tractor. At the 2100-ft range, the exposed D-7 tractor received much less damage, although damage still exceeded organizational capabilities for repair. The protected D-7 tractor received damage essentially identical to the D-8 at 1600 ft. The use of unserviceable equipment for test purposes prevented an on-the-spot test of the observed condition of

A13314 Fig. 8. Caterpillar D-8 angledozer, 1600 ft; after test.

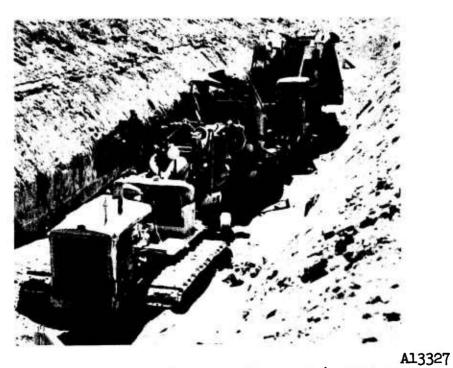
Fig. 9. Caterpillar D-7 (without attachments), 2100 ft; after test

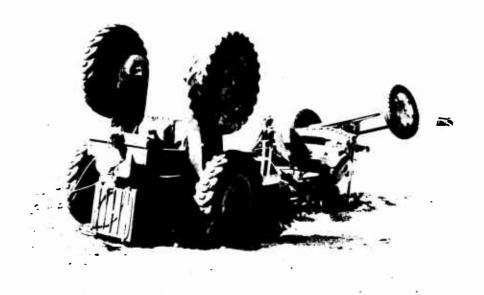
(see also Fig. 8). In Fig. 12, GZ is to the left front; and in Fig. 13, GZ is behind the camera. Fig. 13 shows the condition of the grader after the test was conducted at 2100-ft range. When this figure is compared with Fig. 7, it can be seen that the sturdier, more compact tractor suffered less damage than the grader did under the same conditions.

Fig. 13. Grader, 2100 ft; after test.

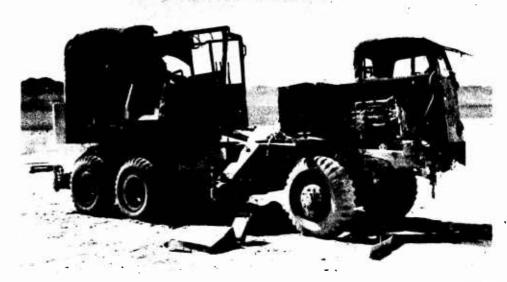
c. Cranes. At the 2100-ft range, the exposed crane was destroyed, and the protected crane received a surprisingly high degree of damage. At the 2700-ft range, the exposed crane still received extensive but moderate damage, while the protected crane was moderately damaged but to a lesser extent because of the shielding effect of the slot. (See Figs. 14 through 19 and note the sheet metal panels of the crane housing and cabs, particularly inside the slots.) Booms and other attachments would have been damaged in about the same degree as the cranes themselves.

Fig. 19. Crane, 2700 ft; after test.

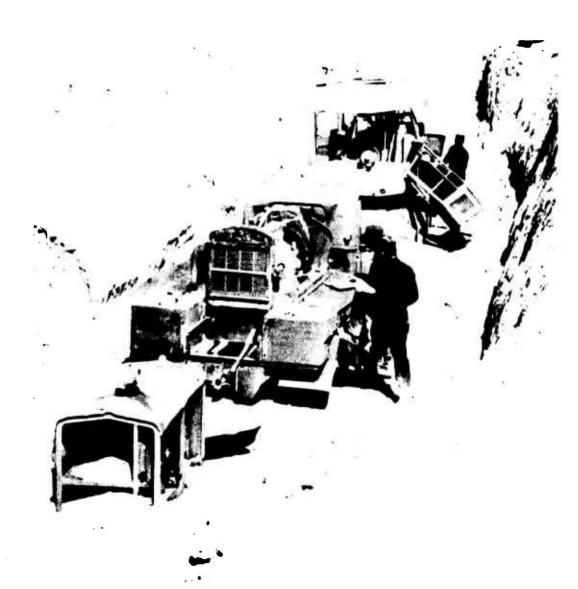
Fig. 21. Compressor, 2700 ft; after test.

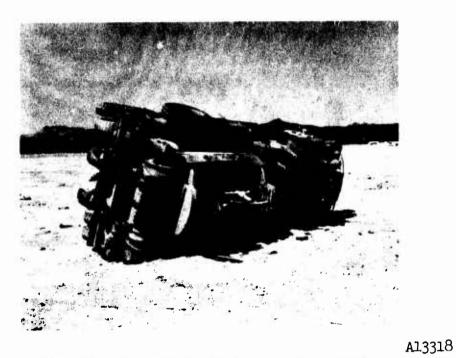
Fig. 23. Compressor, 2700 ft; after test.

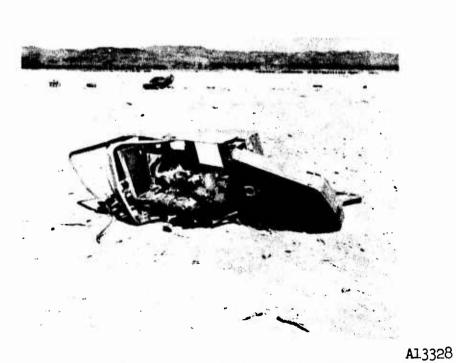
- e. Generators. At the 2100-ft range, the exposed generator was destroyed; and at the 2700-ft range, damage was moderate. The slots provided fair protection; at the 2100-ft range, damage was reduced to the moderate category; and at the 2700-ft range, to the light category. Figs. 20, 24, and 25 show the generator separated from its skid or pallet mounting after test (also see Fig. 26). A smaller slot would have limited the reflected shock wave and displacement, and would have decreased the resulting damage.

Fig. 24. Generator, 2100 ft; after test.

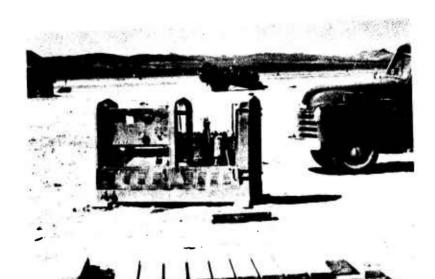
Fig. 25. Generator, 2700 ft; after test.

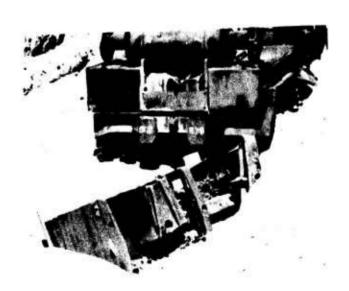
Fig. 26. Generator, 2100 ft; after test. (inset from Fig. 17)
